**Report of Dr. Brenton Cox
Regarding the May 31, 2017
Explosion at Didion Milling in
Cambria, Wisconsin**

March 31, 2023

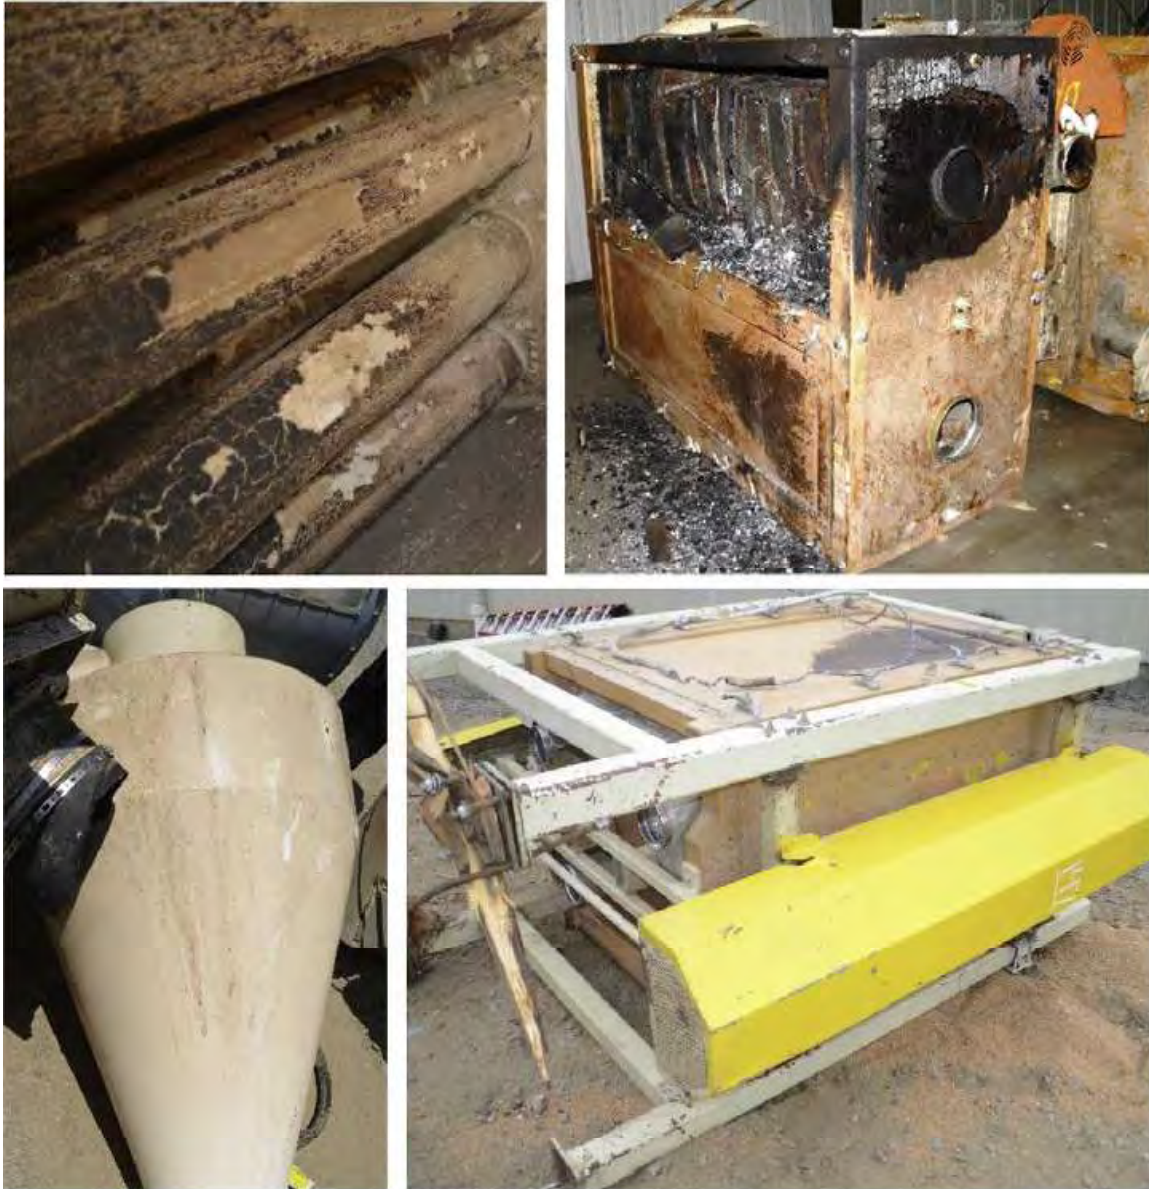
Figure 5. Damage to a set of filter socks, box sifter, filter, and first break cyclone (clockwise from top left) in the flour mill facility explosion discussed in Smyth et al. (2019).⁵⁰

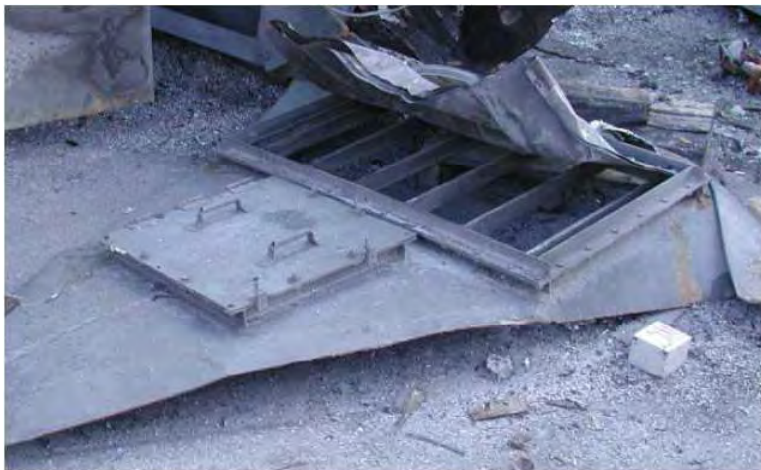
Figure 6. Fragment of drop box after internal propagation from the dust collector occurred during the incident at Hayes Lemmerz International in 2003.⁵⁴

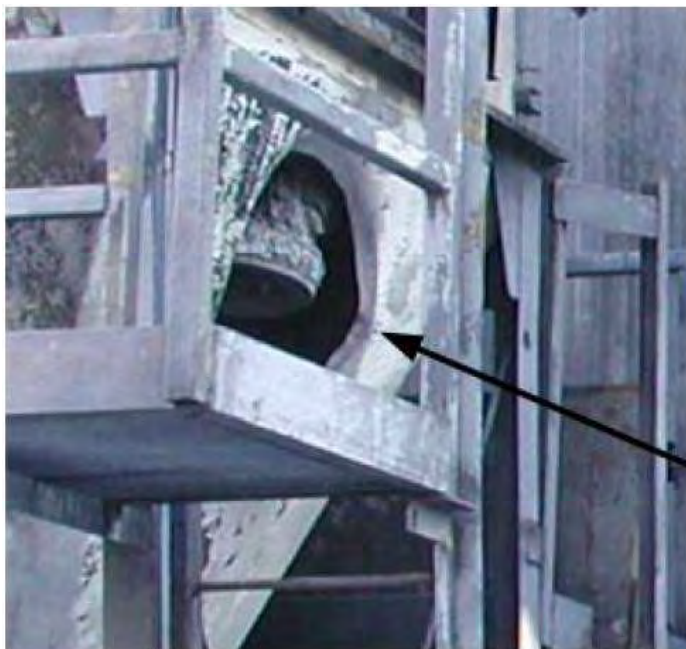
Figure 7. Photograph after the incident at Hayes Lemmerz International in 2003 indicating the short duct that used to connect the drop box to the dust collector before being pulled away by the propagating blast wave.⁵⁵

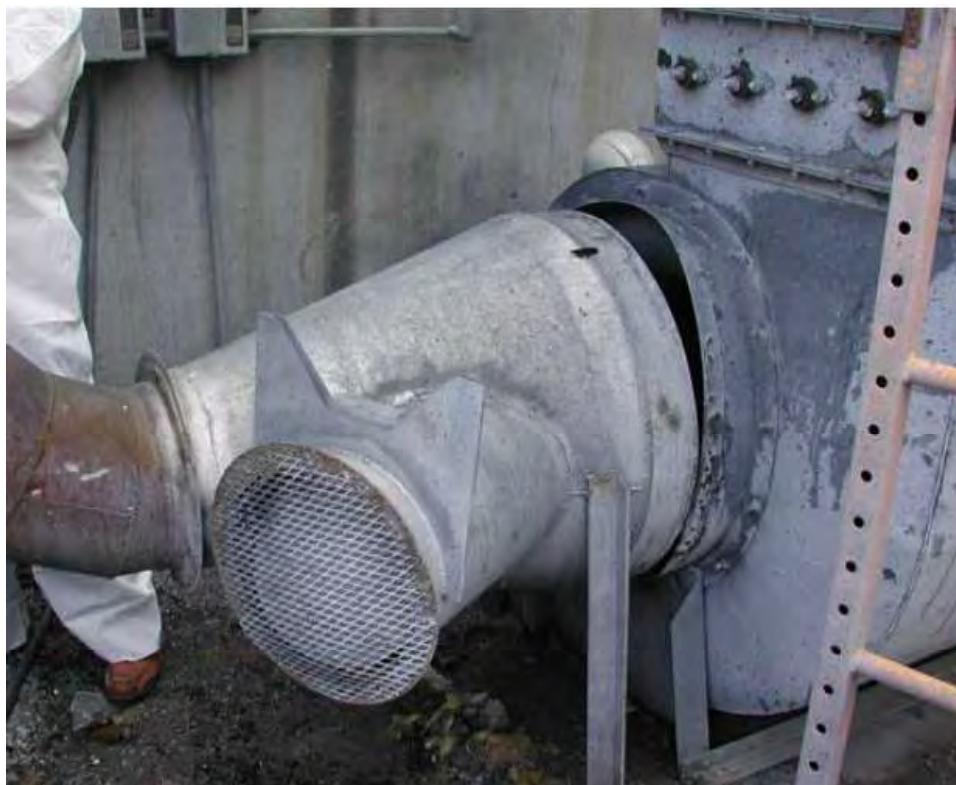
Figure 8. Fume hood exhaust fan cover damaged by deflagrations inside the ducting and fan housing during the incident at Hayes Lemmerz International in 2003.⁵⁶

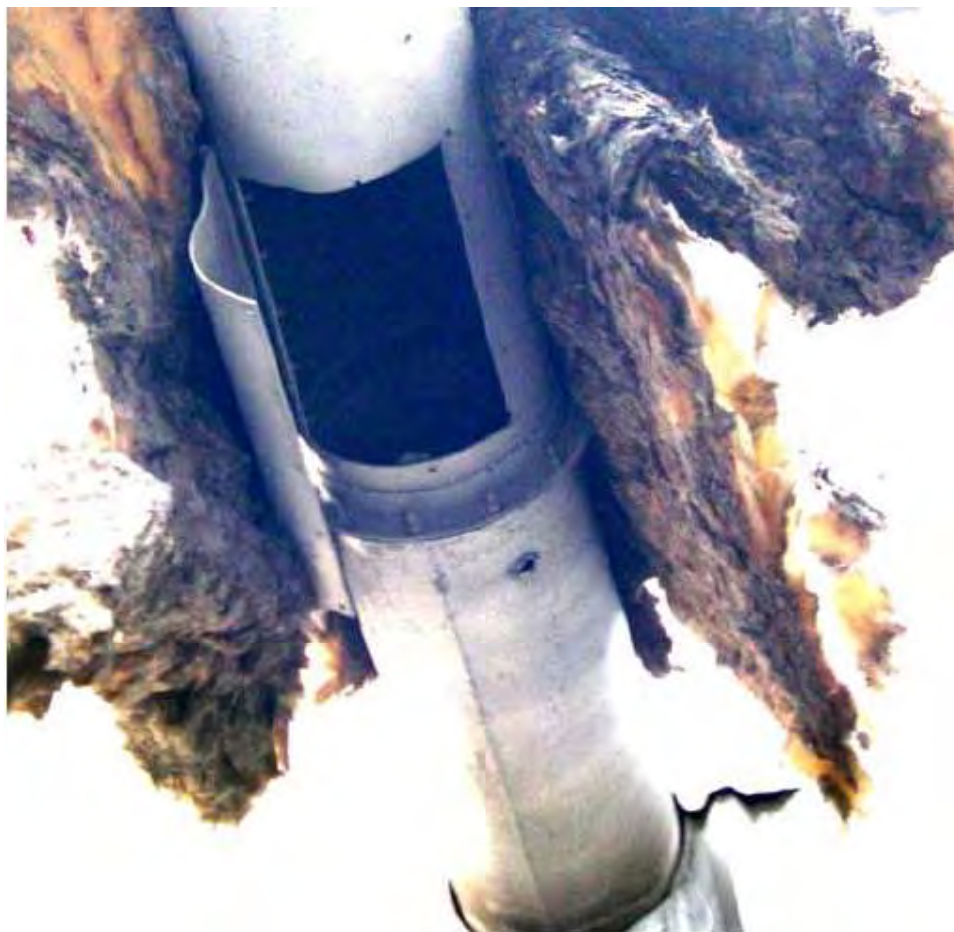
Figure 9. Cleanout door on the duct from a fume hood to fume separator. The door was blown open as a result of internal propagation during the incident at Hayes Lemmerz International in 2003.⁵⁷

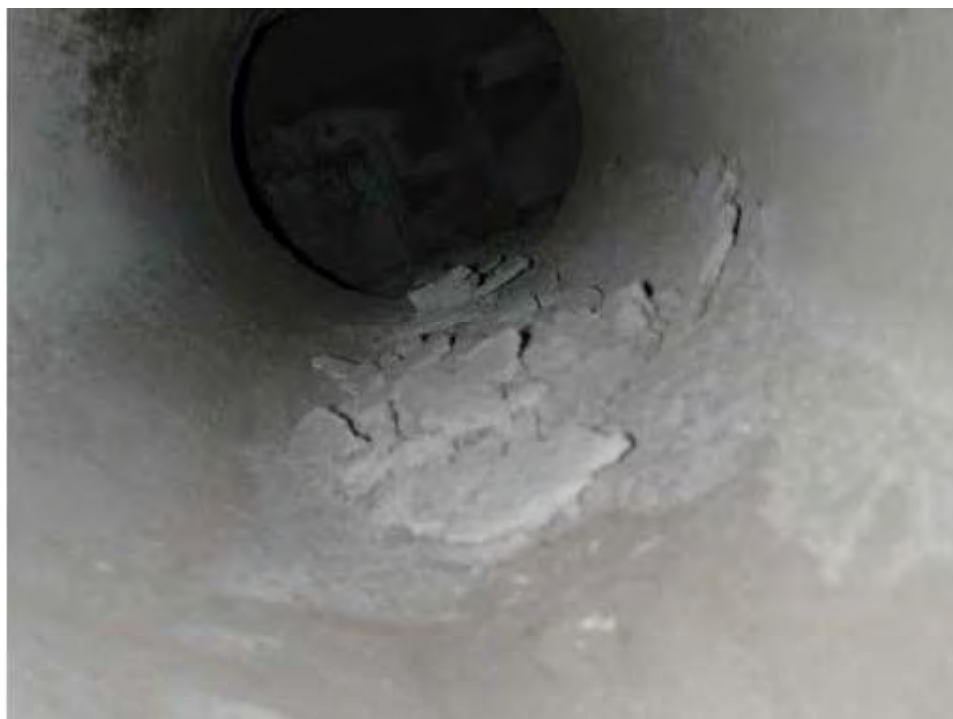
Figure 10. Interior of duct from a fume hood to fume separator near the cleanout door. The CSB identified hard deposits and dust consistent with internal propagation during the incident at Hayes Lemmerz International in 2003.⁵⁸

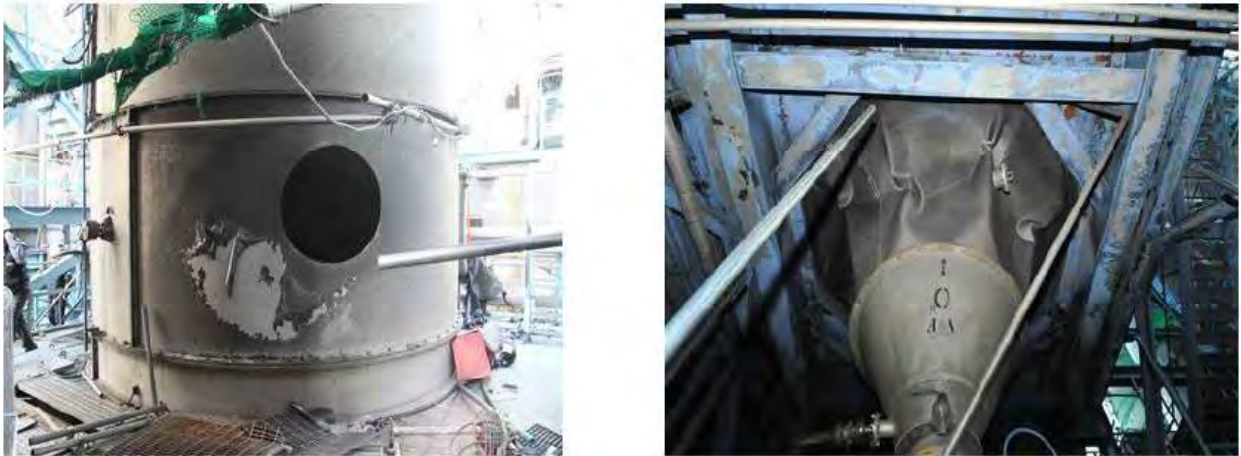
Figure 11. Photographs of the silo where the primary explosion initiated (left) and of a silo bottom affected by sudden impact (right) after the incident at the Yeosu Industrial Complex in 2013.⁶⁰

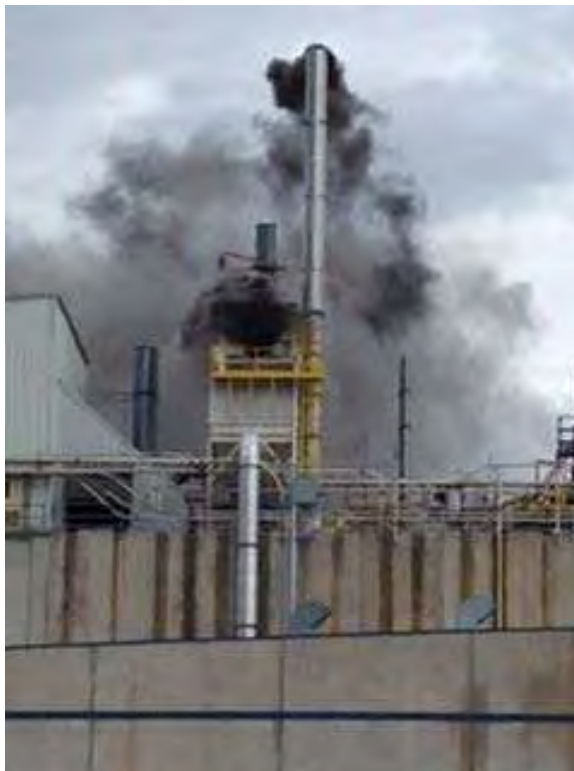
Figure 20. Fire in the Expander 5 filter on May 29, 2017.⁸⁸

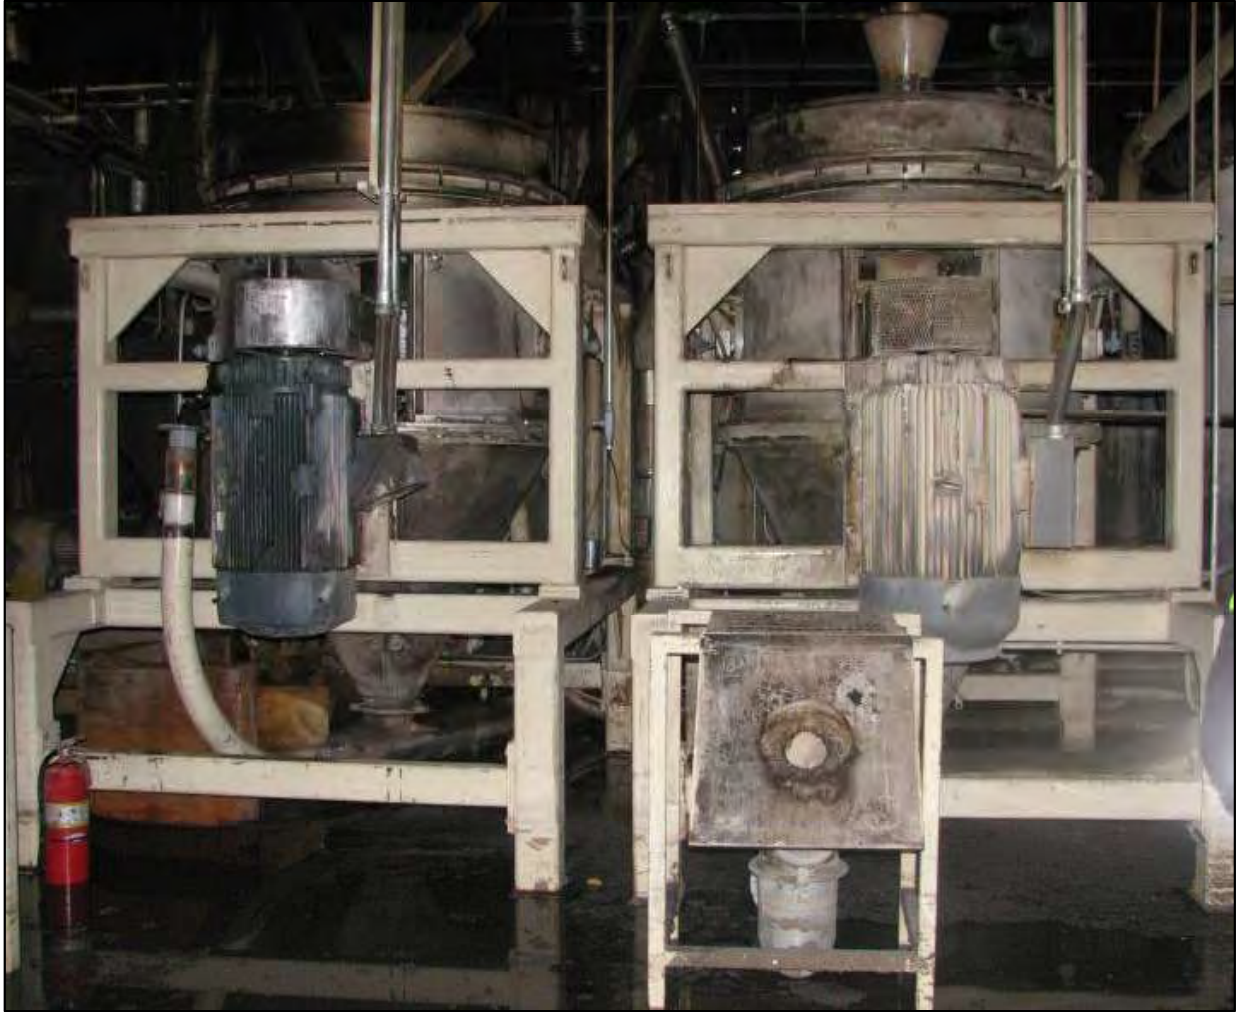
D16670 - 0183

Figure 28 shows the SBM after the incident. Photographic evidence shows that the explosion propagated from the SBM directly into the SBM Cyclone. Damage was also found to a lift line that transports material to the Ground Bran Cyclone on B4, evidence of propagation that could have occurred either through the Torit Filter header or through burning material in the ducting connecting B1 to B4.

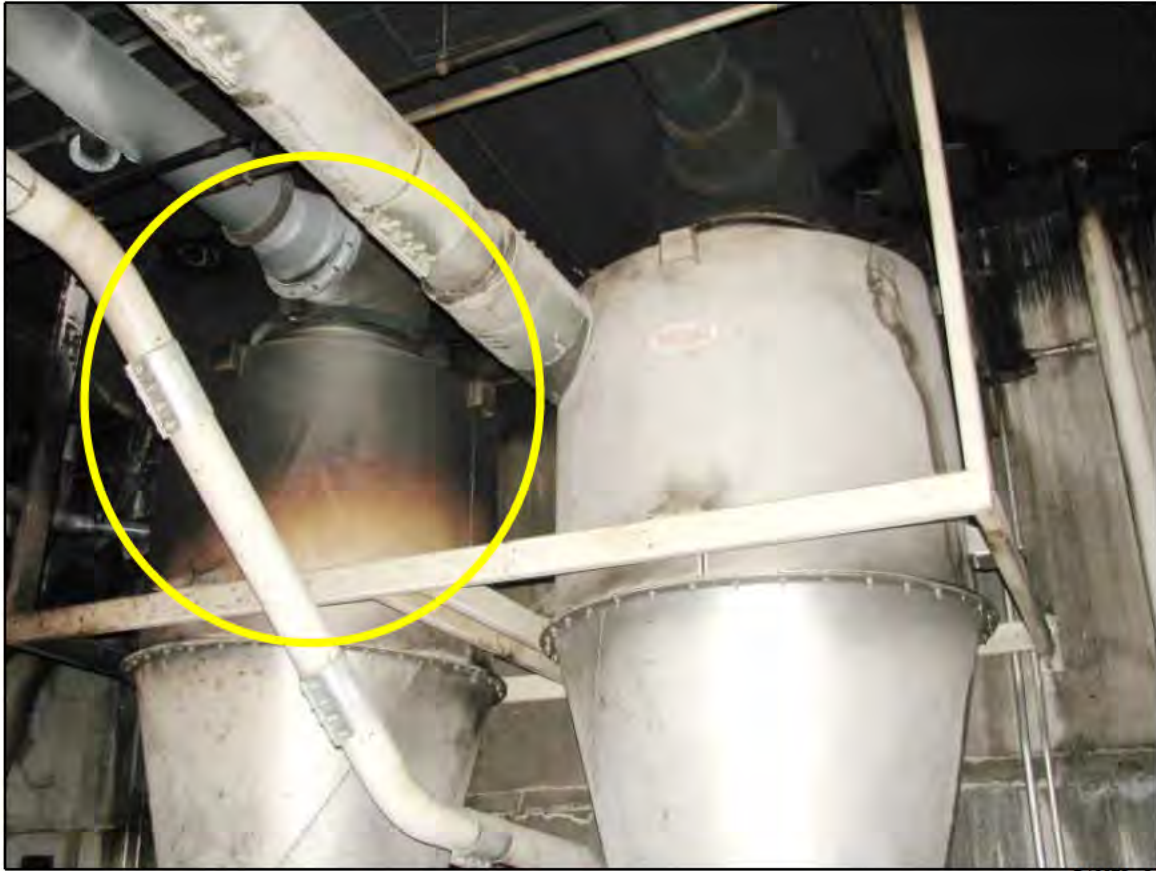
D16670-0144

The SBM feeds directly into the SBM Cyclone (Figure 28). Heat damage to the SBM Cyclone is observed in Figure 29 through the discoloration on the top of the SBM Cyclone. The ducting at the top side of the SBM Cyclone is directly fed from the SBM.

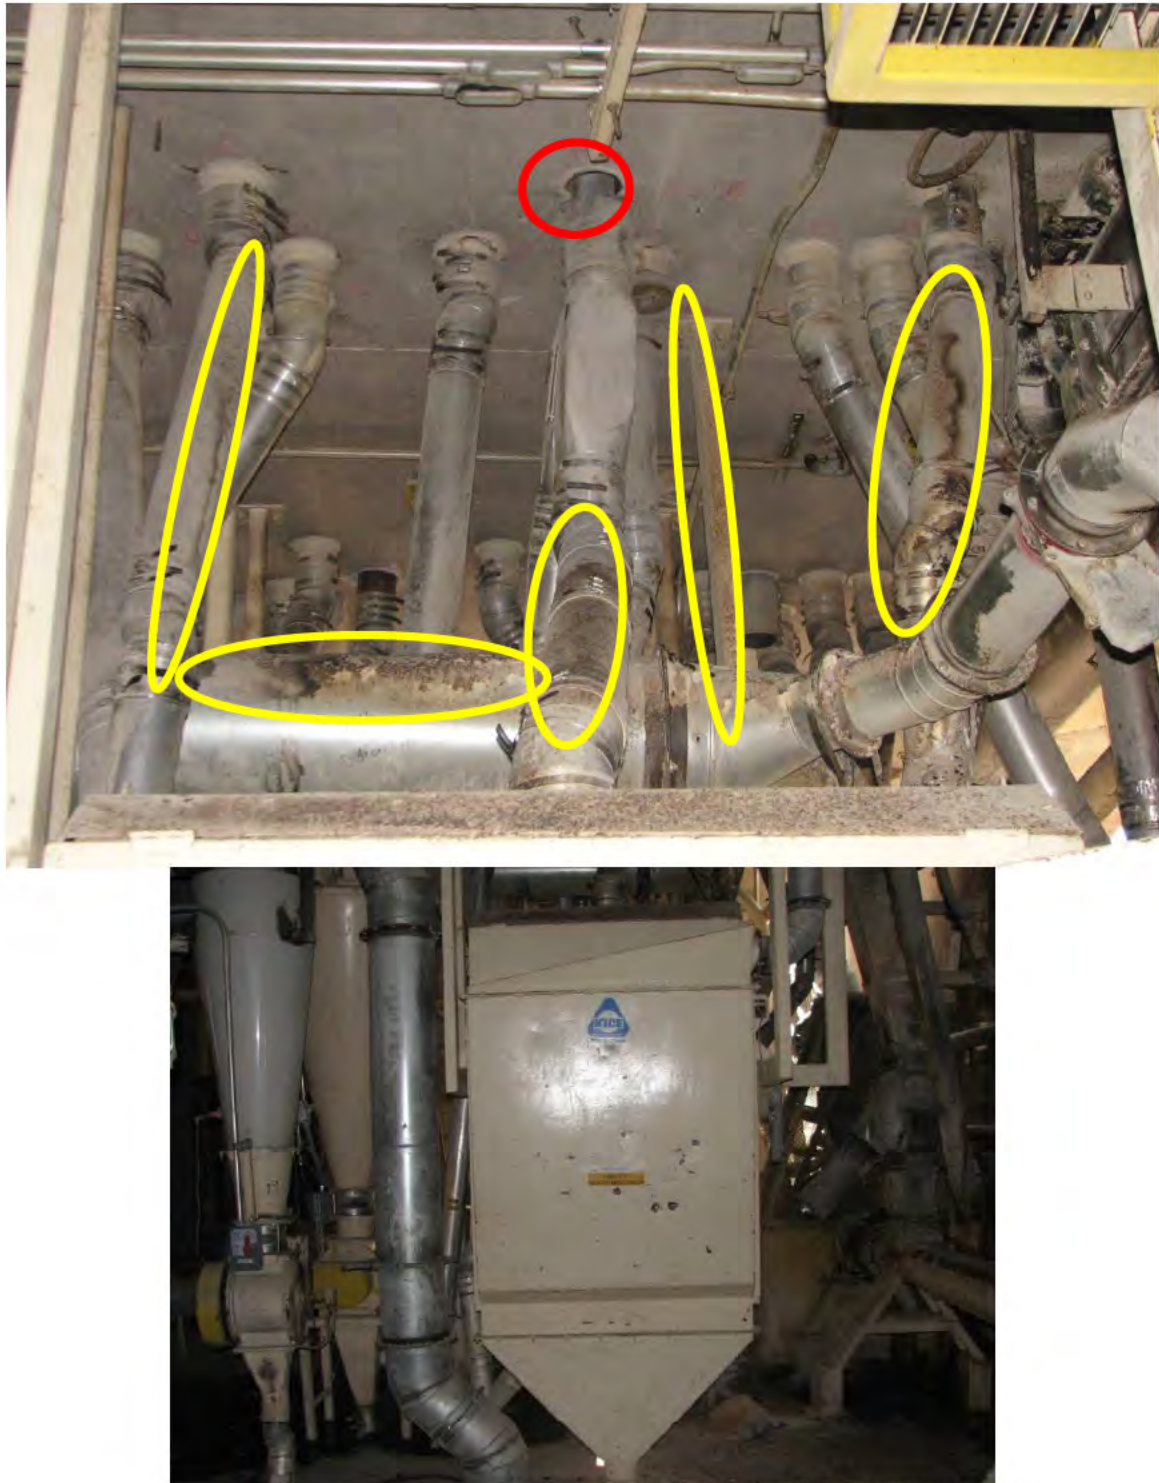
D16682 - 0400 (bottom), D16682 - 0405 (top)

As shown in Figure 33, the ducts connecting the North Bran Aspirator on B3 to the 6-section Bran Sifter on B4 were found disconnected. Note in the top image that there were clear burn patterns from the opening of the ducts and fuel splattering on adjacent piping through the duct opening. This burn pattern is indicative of an internal flame/deflagration source as compared to an external source. Note minimal, if any, fire damage was observed on the ceiling from B3 due to an external explosion.

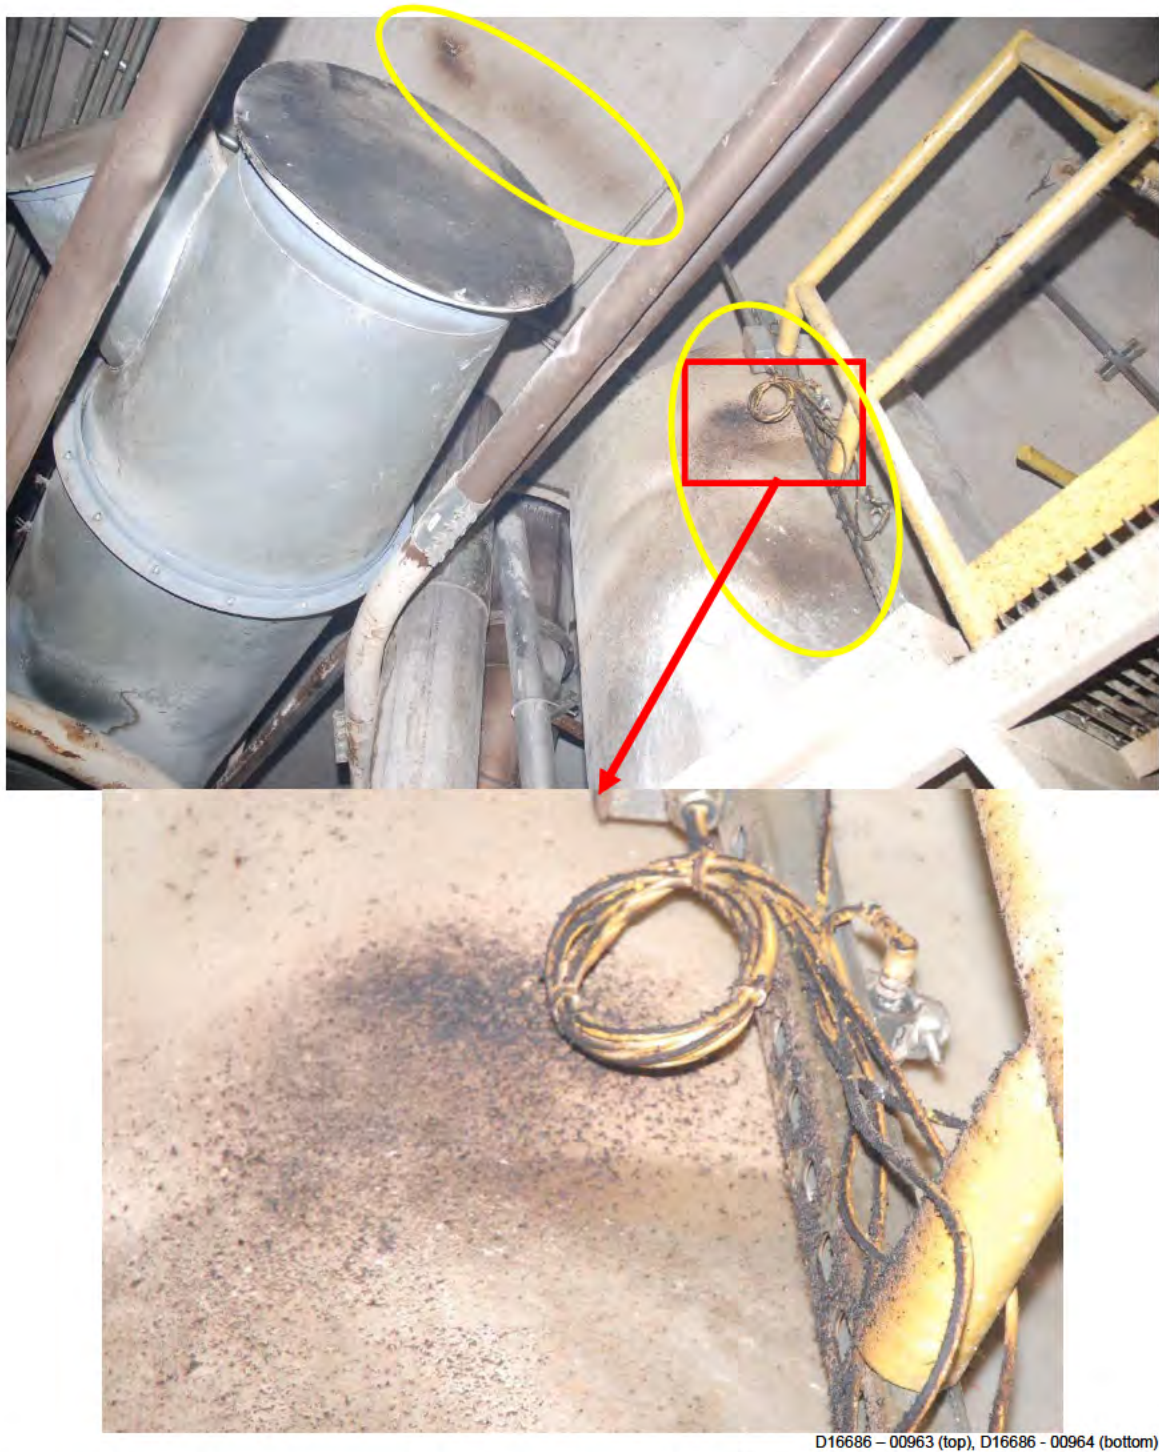
Figure 37. Close-up view of the apparent scorch marks in Figure 36 post-incident. The texture created by partially burned material ejected from the 36" Torit Filter Header (top) deposited on wires and other surfaces can be seen more clearly (bottom).

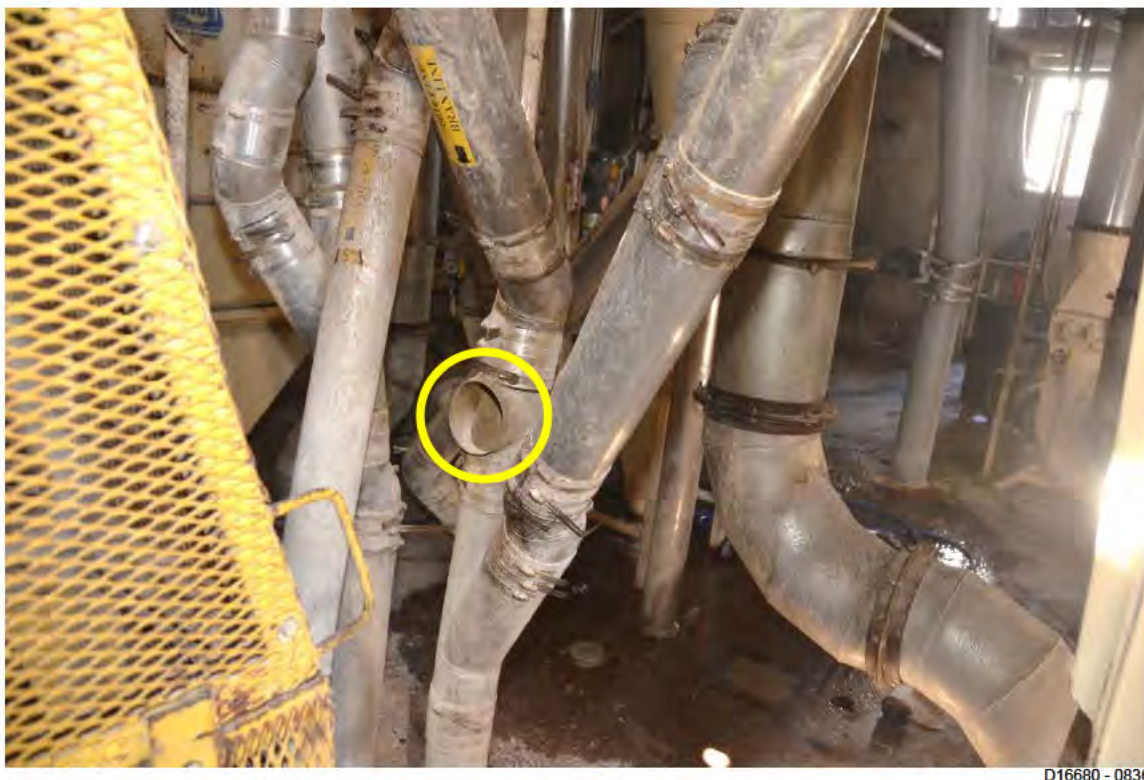
Figure 40. Post-incident view of 8010 Fine Bran Line on the 3rd floor of the B-Mill with detached cap.

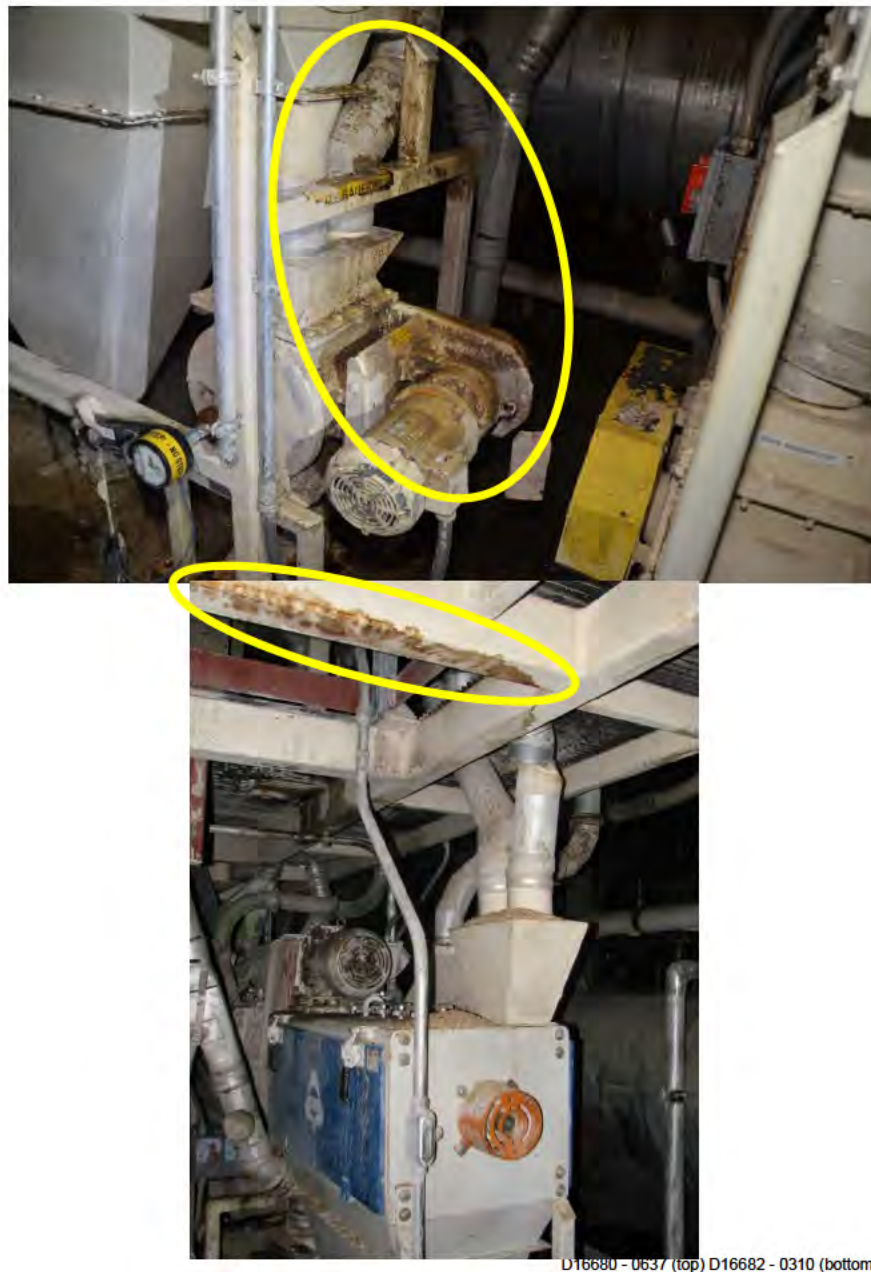
Figure 43. Post-incident view of splatter on Bran Polisher (top) and mezzanine support structure (bottom) from product ejected from separated ducts due to internal overpressure.

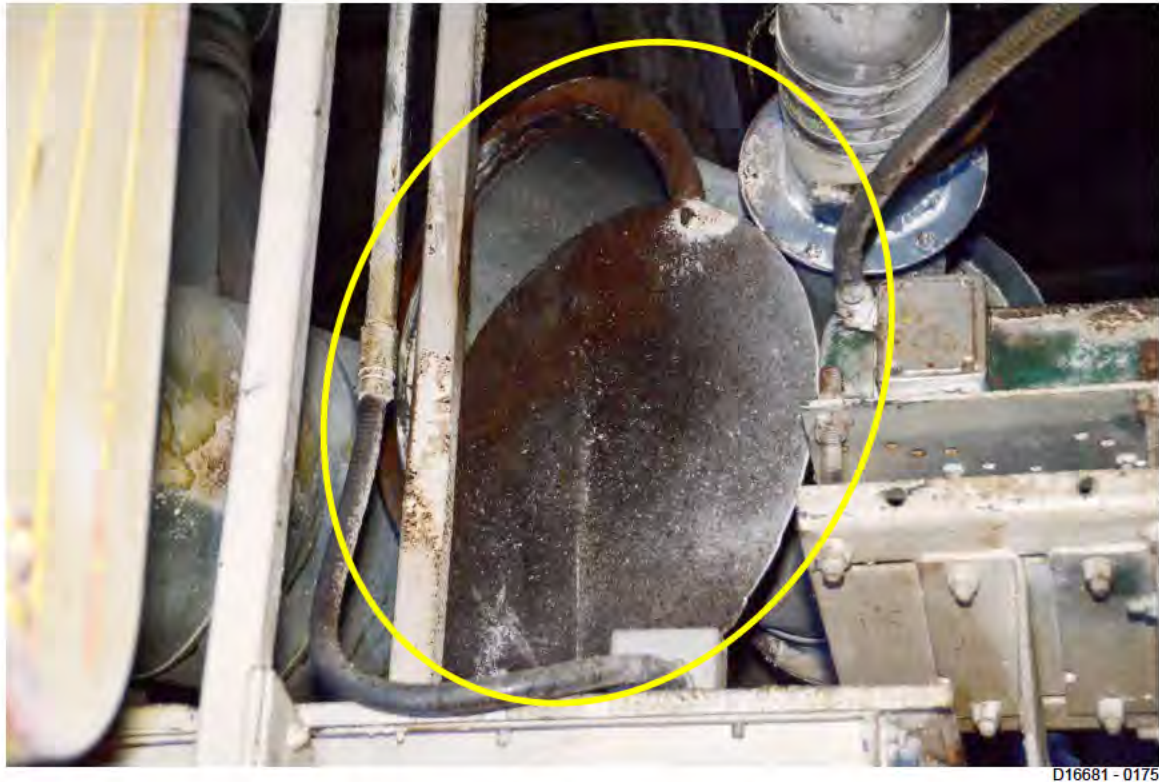
Figure 48. Post-incident view of blind duct on second floor of A-Mill (A2) found open after the incident.

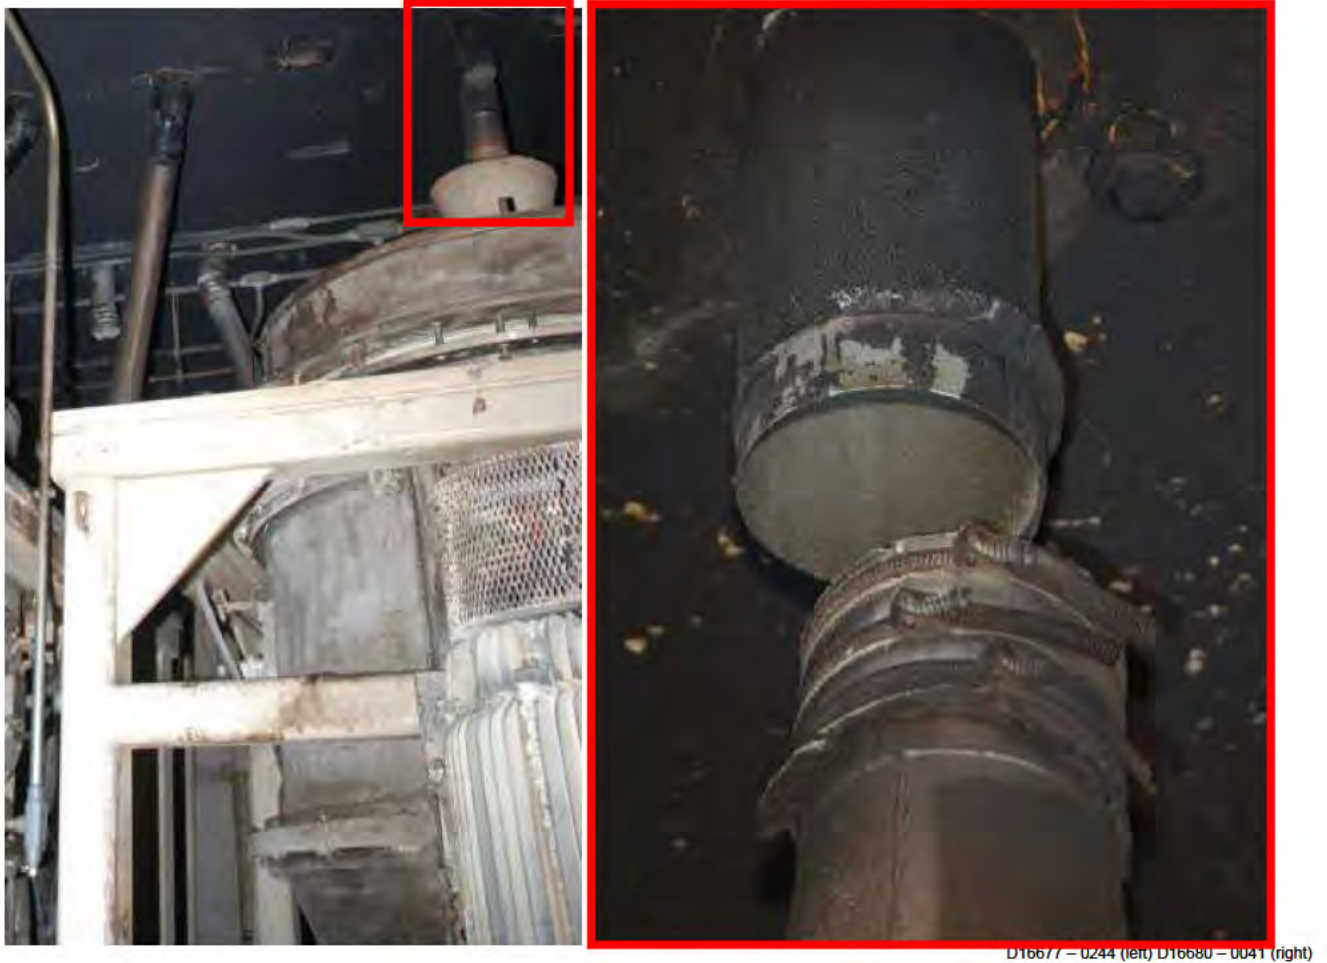
Figure 49. Post-incident view of North Bauermeister (left) with zoomed in image of severed inlet ducting (right).

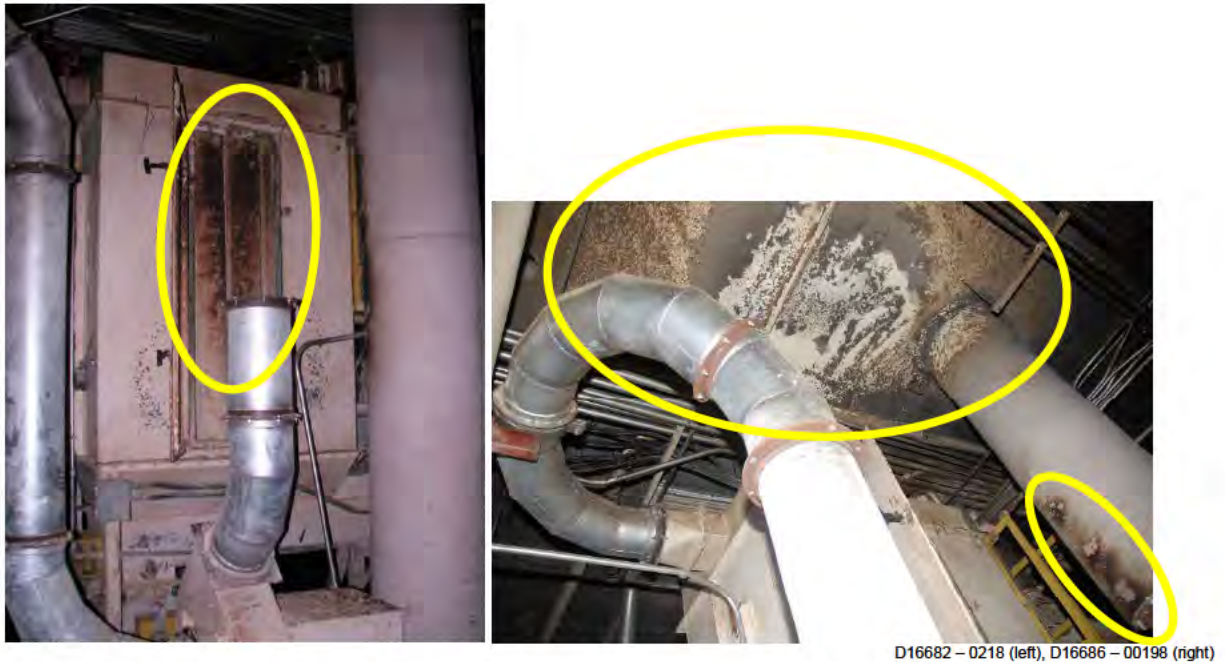
Figure 51. Evidence of burning material being ejected from the duct in front of the Coarse Grinder Filter on other equipment (left) and the ceiling (right) in post-incident images.

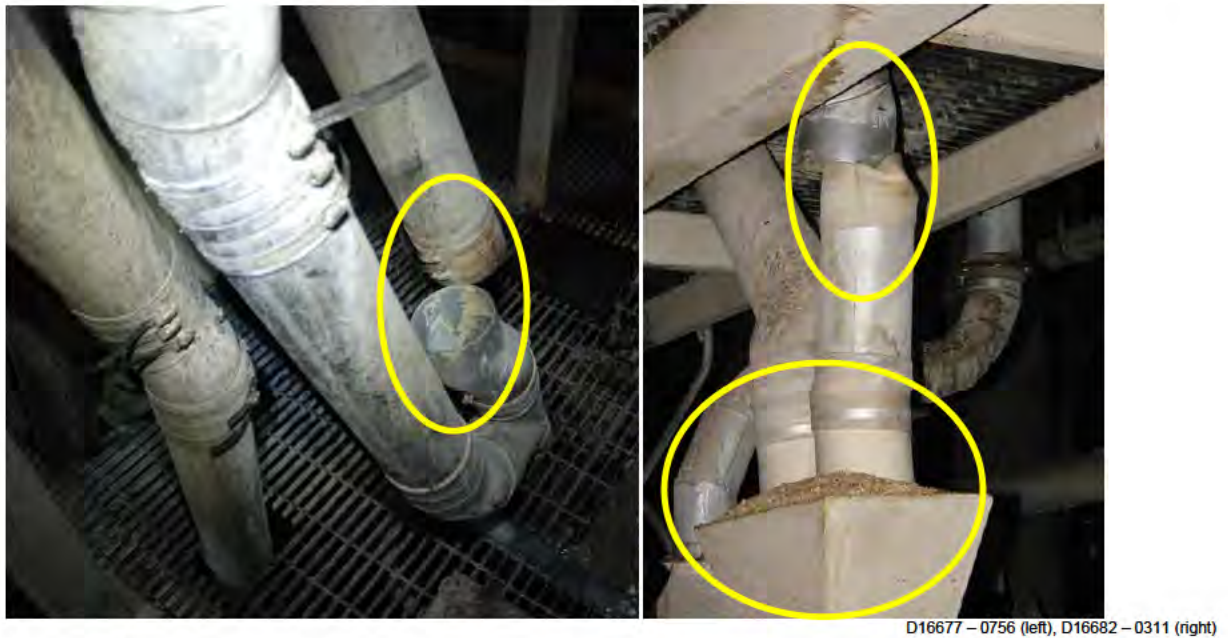
Figure 56. Post-incident view of separated ducts associated with the North Bran Polisher (left) and South Bran Polisher (right) immediately upstream of the South Bauermeister.

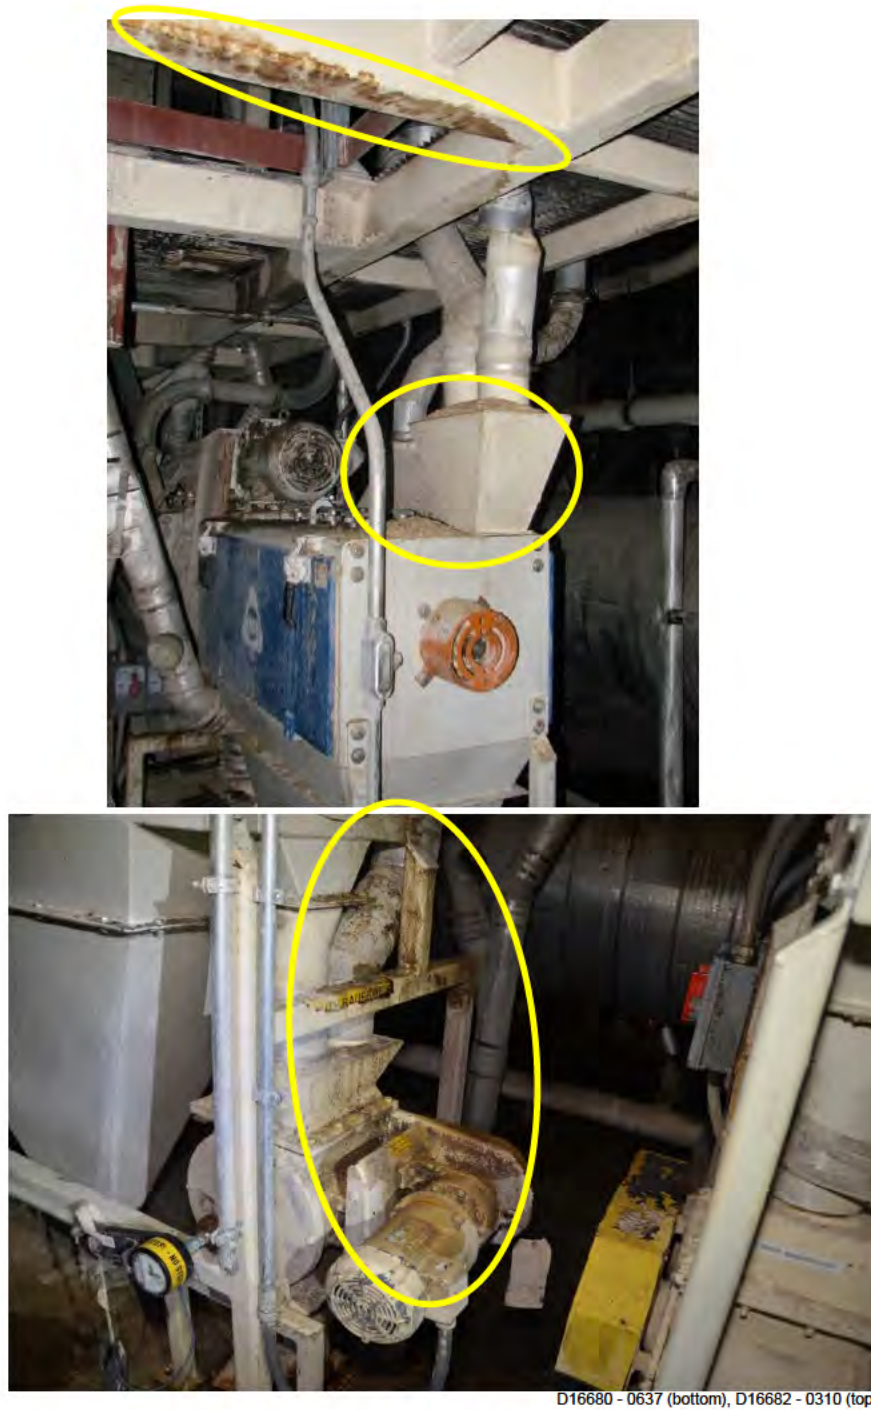
Figure 57. Post-incident view of splatter and burned material on a mezzanine frame (top) and between the North and South Bran Polishers (bottom) from separated ducts.

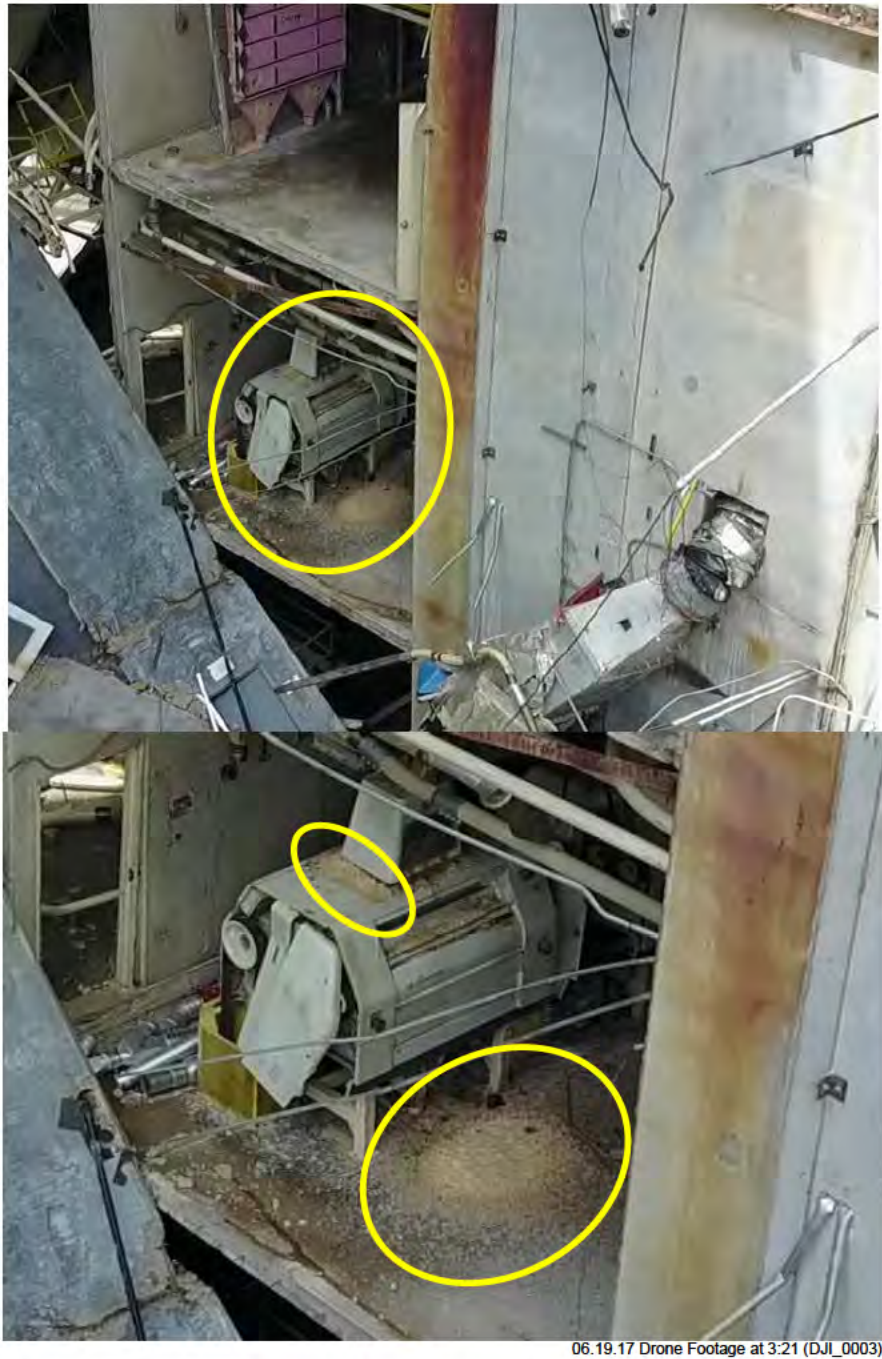
Figure 58. Post-incident aerial view from drone footage (cropped) showing ejected product on and near a roller mill in the southern portion of the 2nd floor of B-Mill.

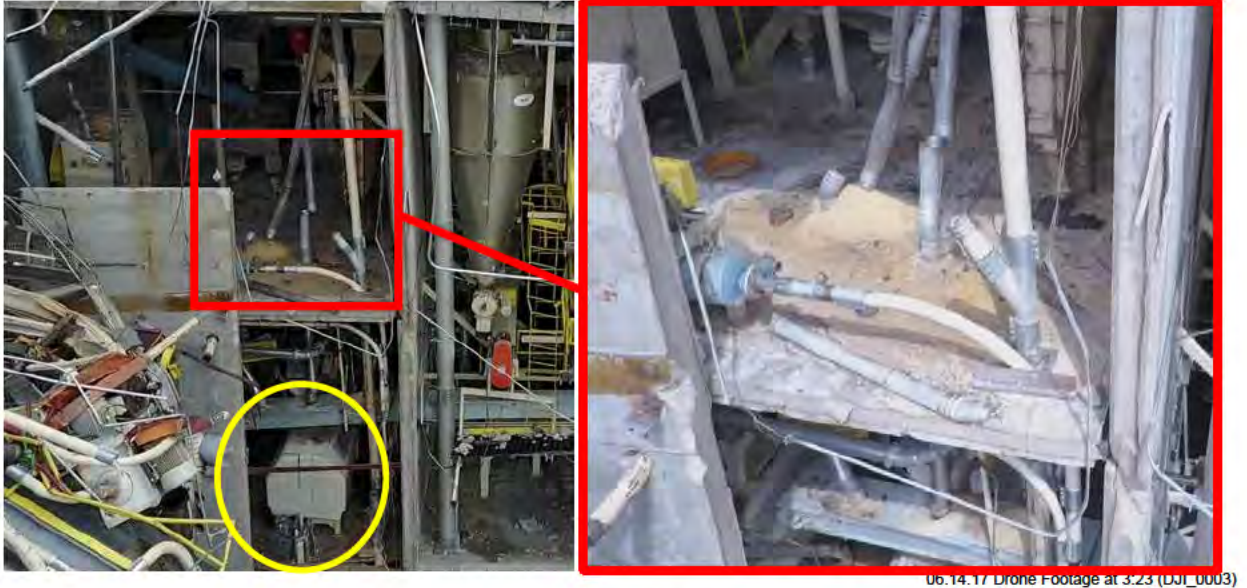
Figure 59. Drone footage (cropped) showing grain accumulation from severed ducts on 3rd floor of B-Mill and on 2nd floor of B-Mill near roller mill near D-Mill (left). Zoomed in drone footage of grain accumulation from severed ducts on 3rd floor of B-Mill (right).

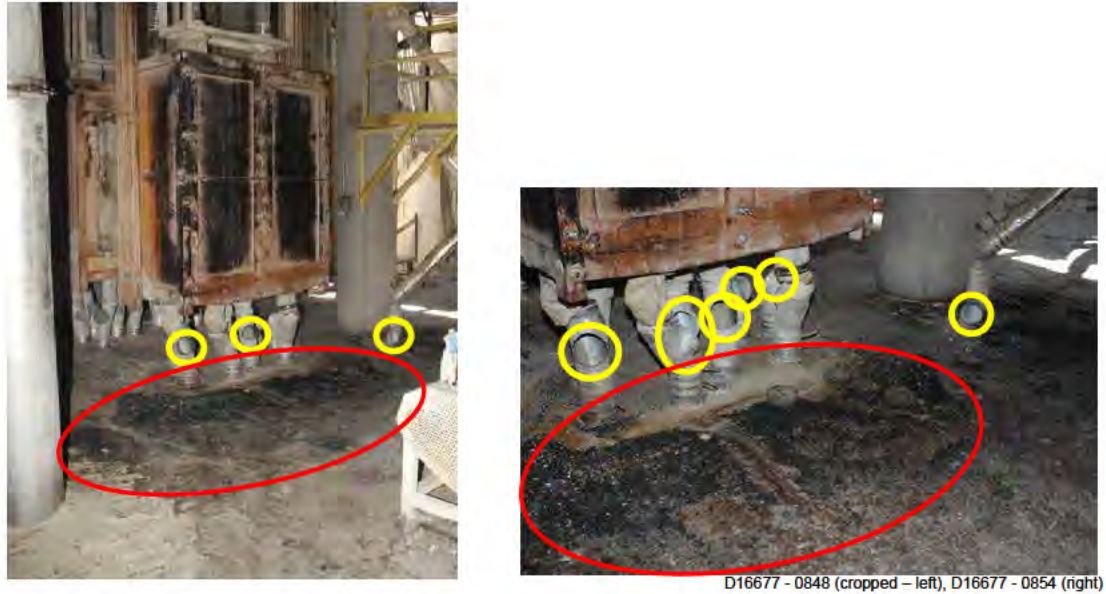
Figure 62. Post-incident view of the 4-Section Sifter on the 3rd floor of B-Mill showing detached caps that were. Burn patterns can be seen on the floor surrounding the ducts. Together these patterns are strongly indicative of internal overpressure displacing these caps and ejecting fuel.

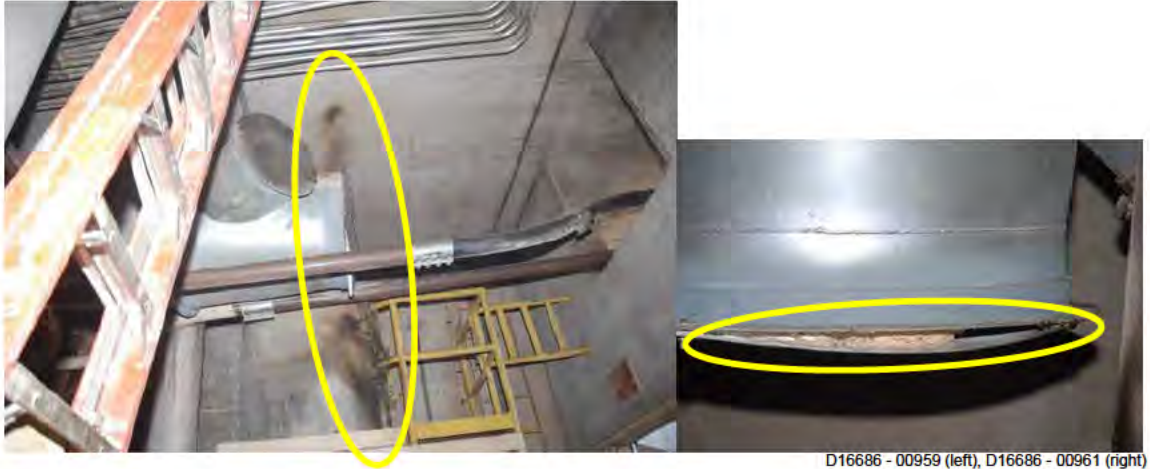
Figure 63. Post-incident view of 12" and 20" blinded lines that were connected to the 36" Torit Filter Header in B3 (left) and zoomed-in end of 20" line (right).
